1995 - 2004 Toyota Tacoma Clock Removal Instructions
www.autoclockrepair.com

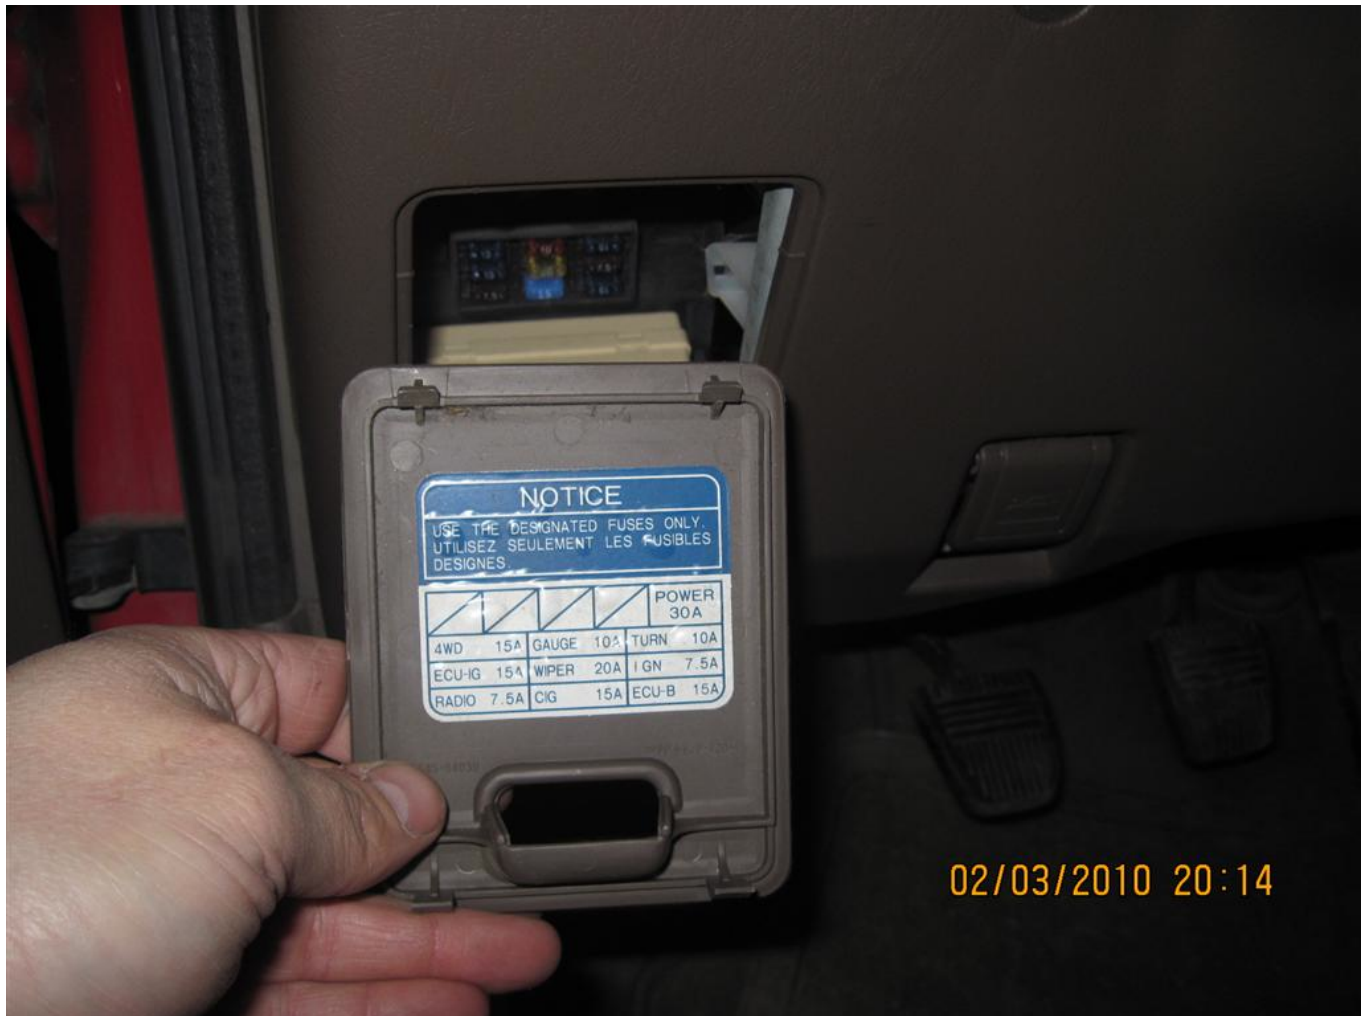
1. Check to be sure that the 15A Cig fuse is not blown. If it is then the clock is OK (no need to send in) and the fuse needs to be replaced. If clock still does not work after fuse replacement continue with removal

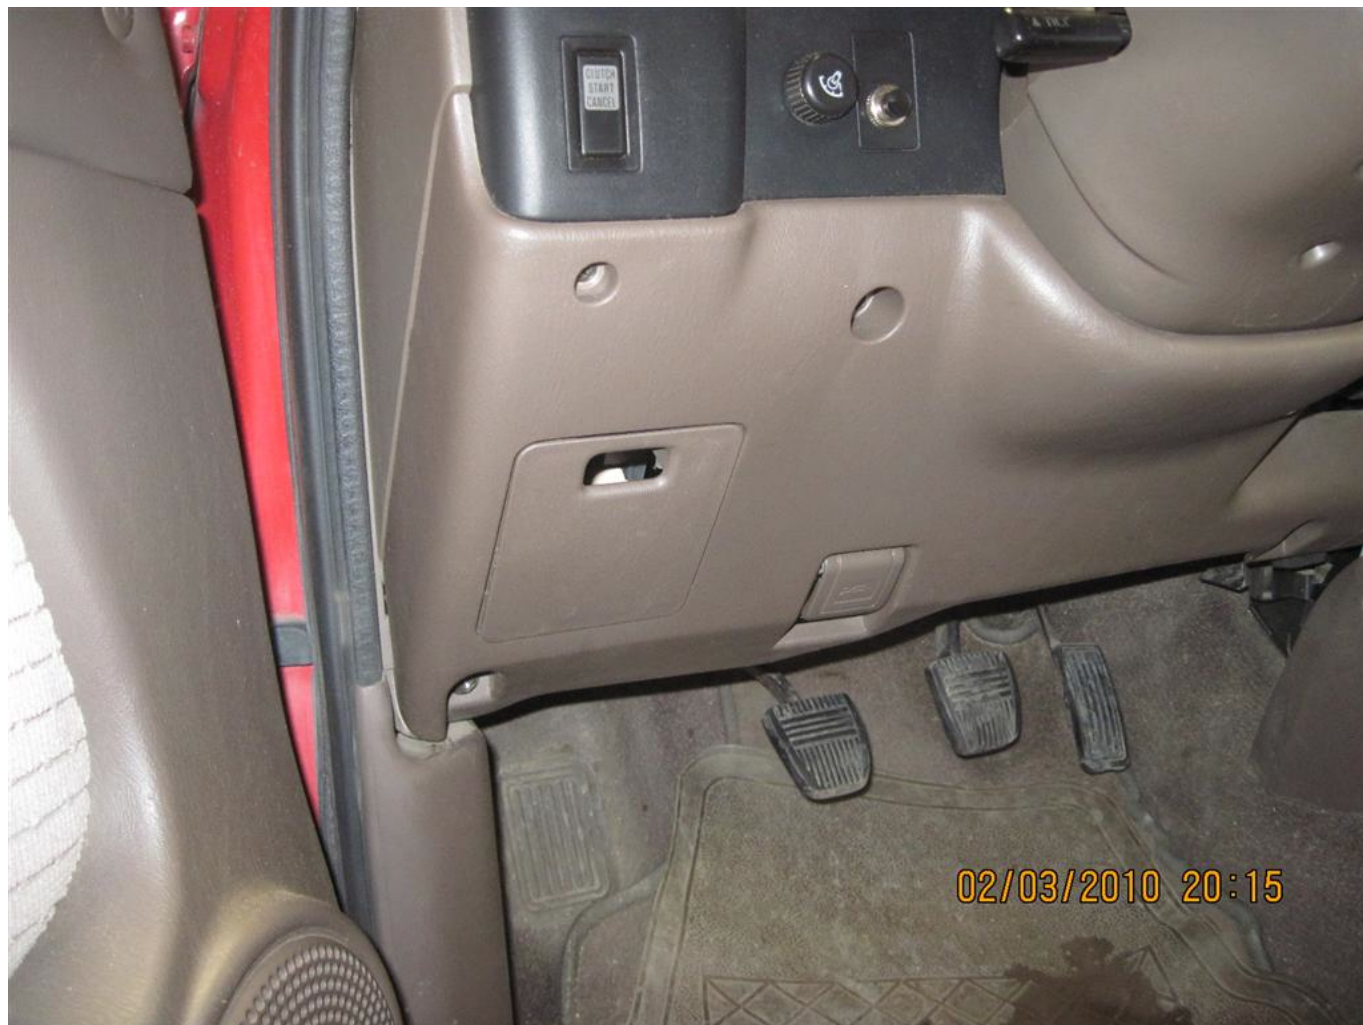
2. Begin by removing the screws on the lower left pane

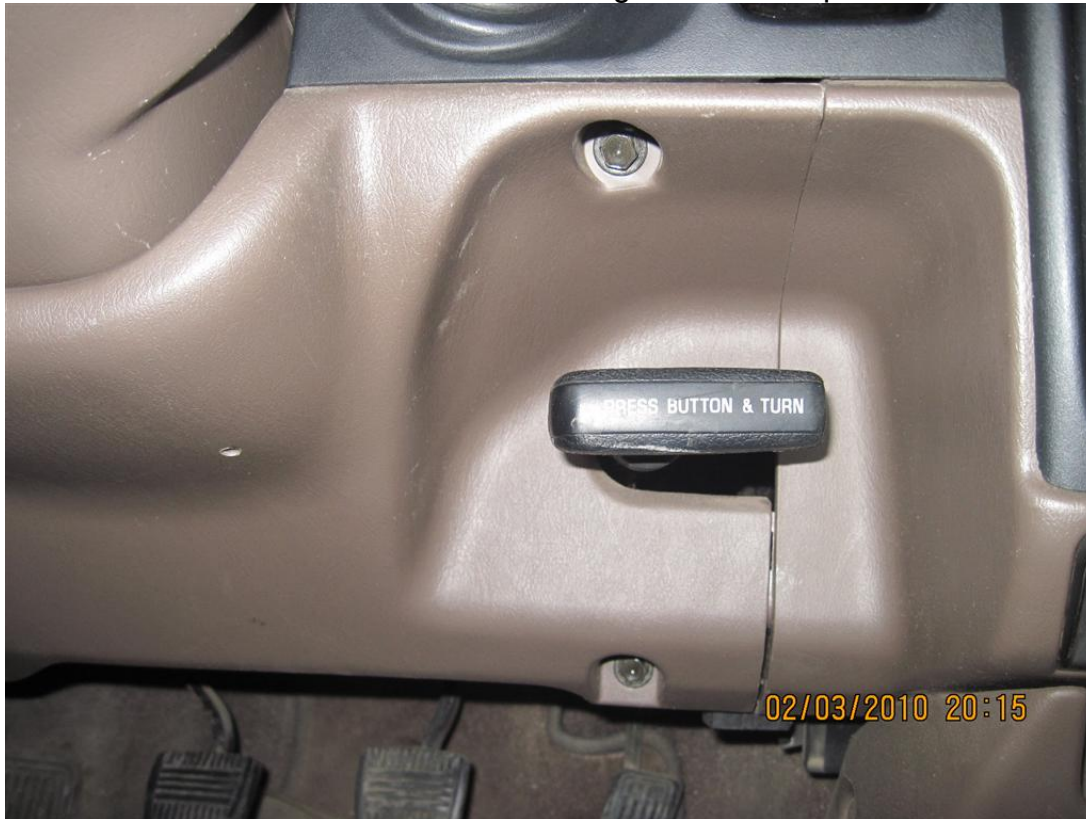
3. Next remove the screws/bolts form the right side of the panel

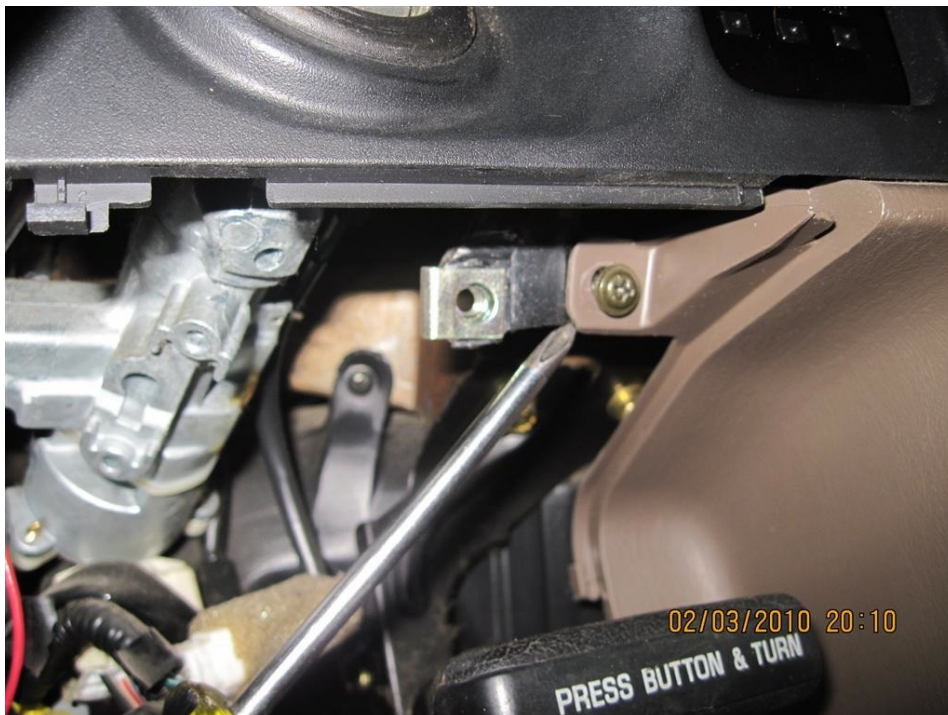
4. Remove this screw

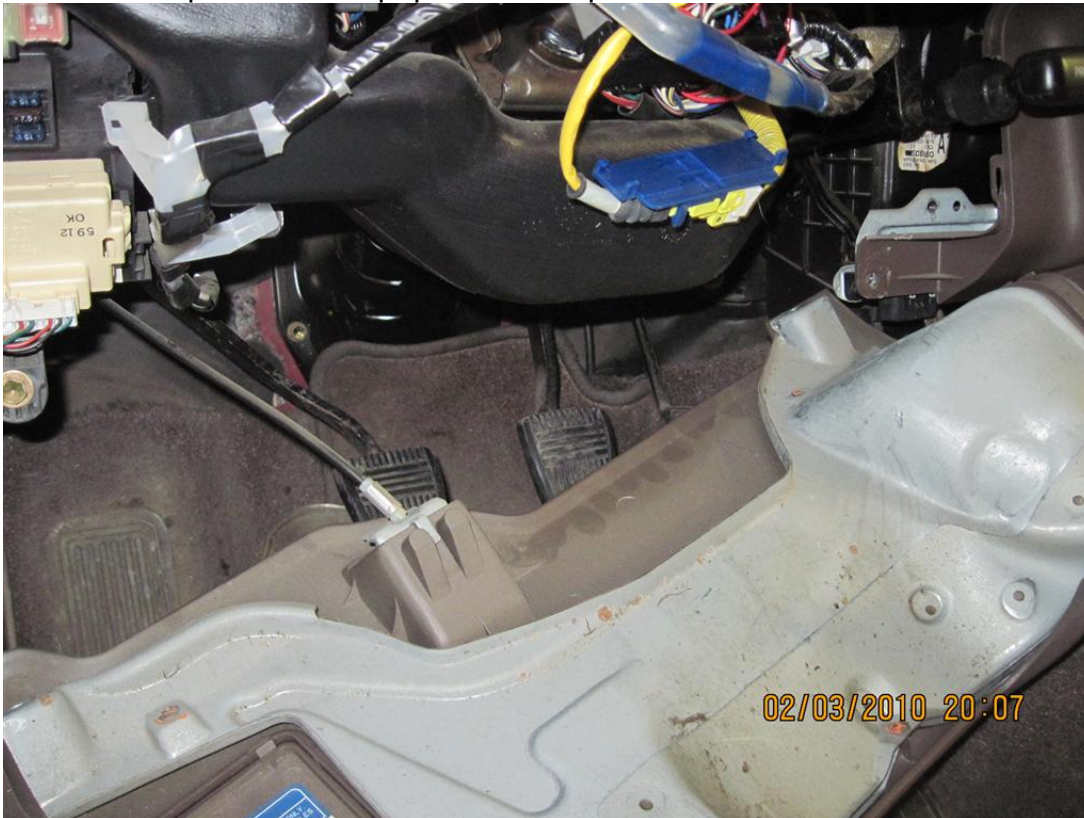
5. The lower panel should pop out at this point

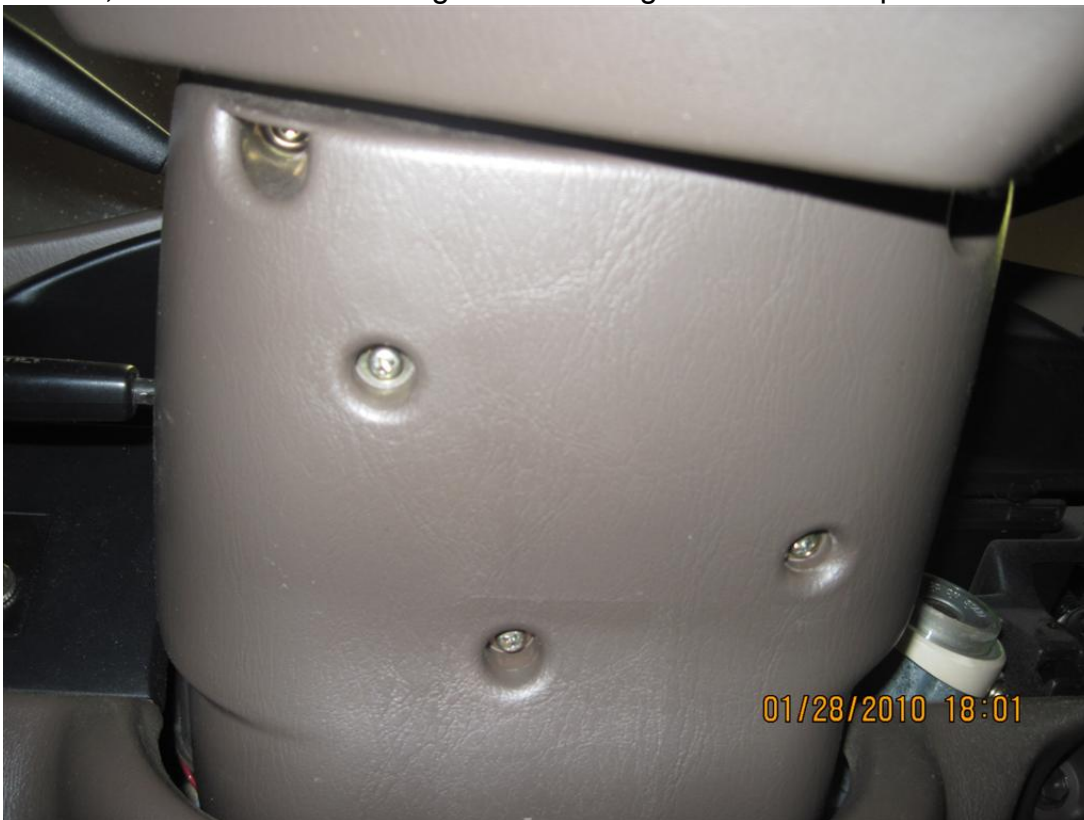
6. Next, remove screws holding lower steering wheel cover in place

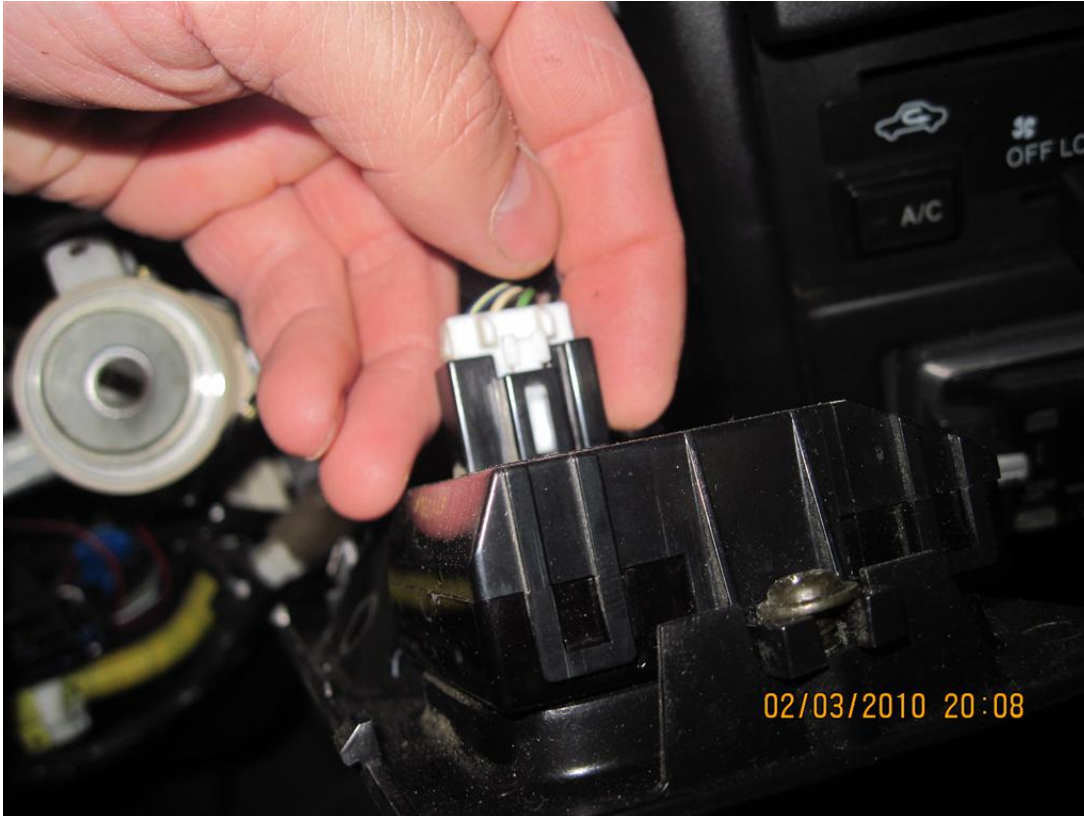
7. You now have access to the clock bezel, remove it and unplug clock from wiring harness

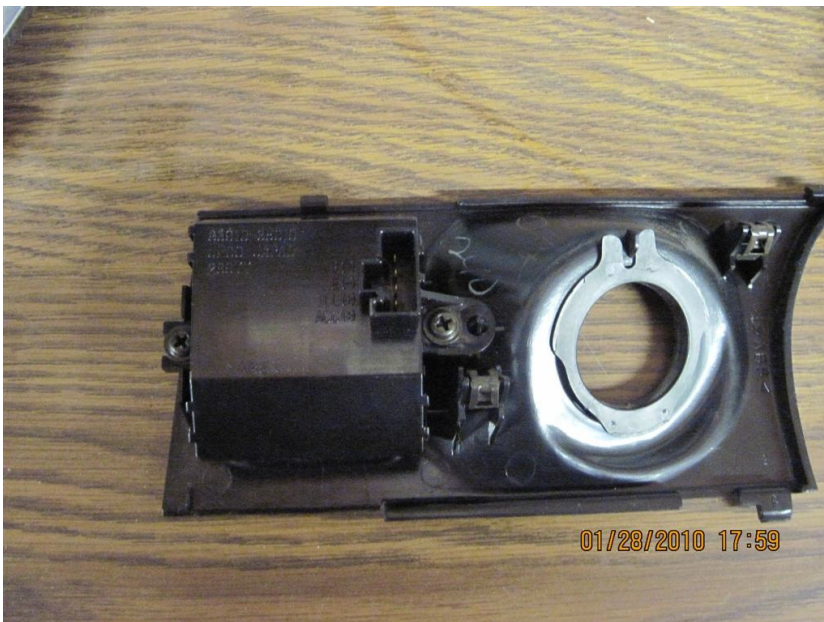
8. Unscrew clock form bezel and you are done!
