1995 - 1998 Toyota 4runner (Hilux) Clock removal instructions

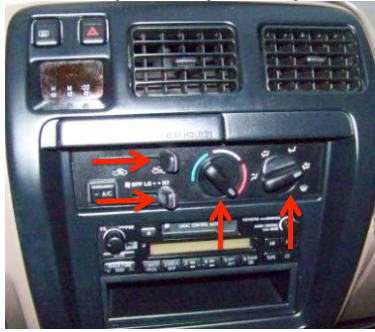
1. Check the dome-light. If the dome light is not working, check the dome light fuse, the light and clock are on the same circuit.

2. Remove the knobs and dials pulling straight out.
