Subaru Impreza/WRX clock removal

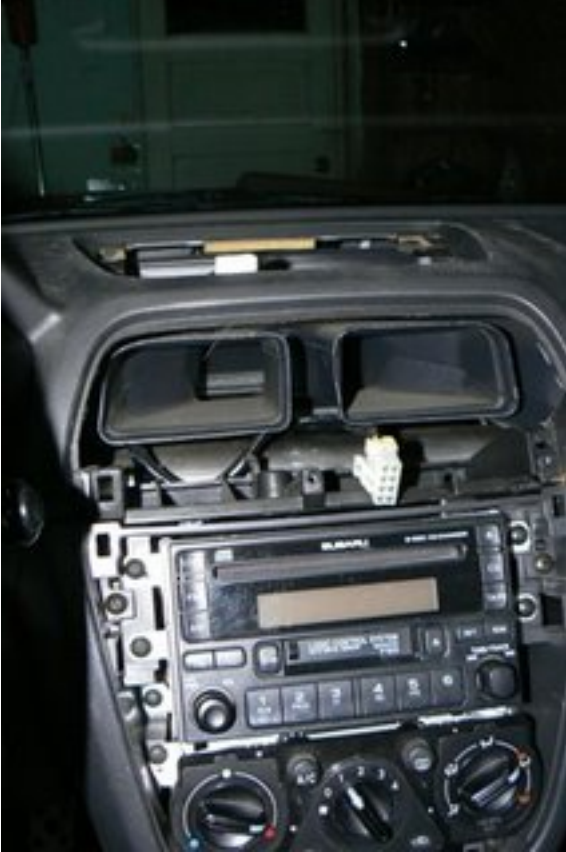
First, I removed the facing around the radio. Then the top piece with the vents and the hazard switch. To do that, I pull out the cup holder and unscrewed the two Phillips screws inside on both sides.

The facing around the radio has four clips, one on each corner. I was not worried about scratching the surface and just used a butter knife. A good suggestion was to use a flat screwdriver wrapped in electrical tape and slowly pry at the corners until the facing pops free.

Then, I removed the plug from the hazard switch and radio using my fingers. I took out the clock module. With a flat screwdriver, I had to press firmly on the clips in the front of the clock pod until it pops up. It took some time to look at how the clips were angled into the plastic and bit of jiggling while pushing on the clips. Eventually it popped off. At this point, I was able to disconnect the plug from the clock. Then pull the four clips off the plastic molding and bring the unit inside to inspect the issue.
