VEHICLE PREPARATION

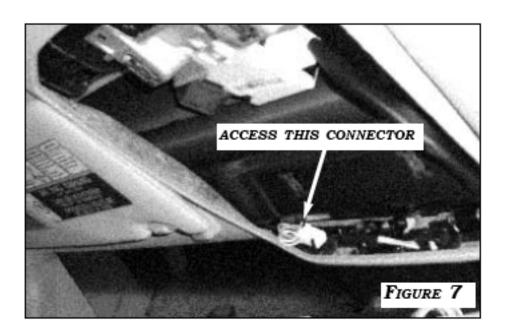
- 1. Remove the overhead console by removing six (6)
 Torx-20 screws behind the sunglasses, business card
 holders, and dome light area. Figure 1. Note: The console for a truck with a sunroof and other trim levels
 and cab configurations use Figure 2. Disconnect dome
 light harness from front of overhead console.
- 2. Release pivot points in sunglass compartment and remove from overhead console. Figure 3. Remove sunglass compartment deployment dampener by depressing both tabs and pushing dampener through side of console. Figure 4
- 3. For 07 tundra, drill a 7/8" or 22mm hole in right corner as shown in Figure 5. Carefully de-burr the hole. For 08 Sequoia, cut tabs and remove knockout. Figure 6
- 4. Dislodge the white 12-pin vehicle connector from the holding clips shown in Figure 7.
